Early failure detection on engines with multi-point vibration analysis

Use cases and advantages of a novel multi-point vibration analysis for early failure detection on combustion engines

Authors: Dipl. Ing. Michael Ruthrof, Dipl. Ing. (FH) Jonas Reicherter
red-ant measurement technologies and services GmbH
Date: 27.04.2014

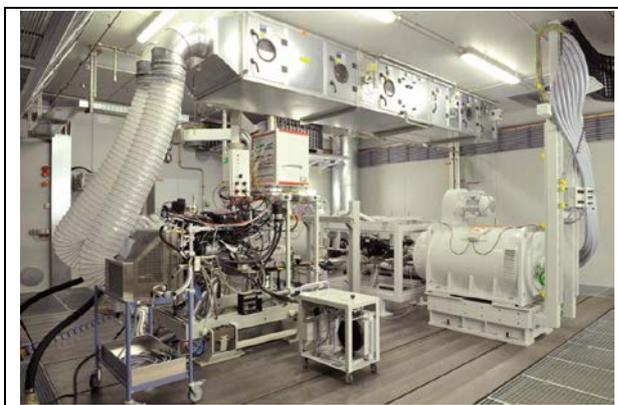
Figure 1: test stand for durability testing of combustion engines

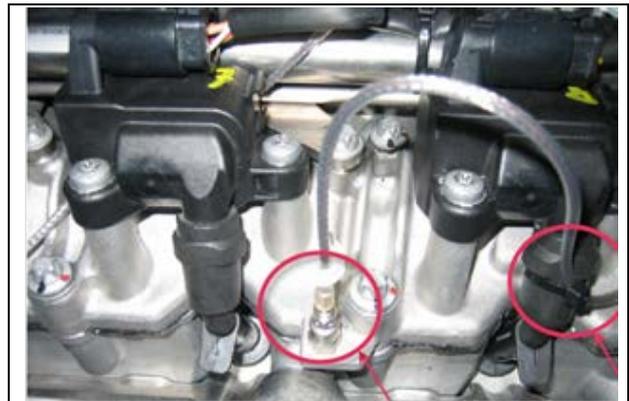
Figure 4: Location of the vibration sensors at the cylinder head

It is important that MIG16 measures the vibration acceleration signals at strategically important locations: crankshaft housing and cylinder-head (see Figure 4 and Figure 5). Sensor location, ground isolation and cable management are important considerations. Red-ant engineers are postured to offer assistance in this important area, based on much experience.

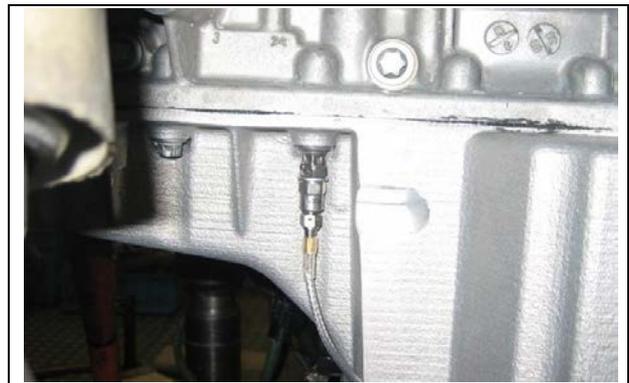
Figure 5: Location of the vibration sensors at the crankshaft housing
